Lake Erie Shore Erosion
A Solution for Conneaut's Shoreline Recession Problem

A Thesis
Presented for Fullfillment of the Requirements
for the Degree of Bachelor of Science

by
Susan F. Finta
The Ohio State University
Spring 1983

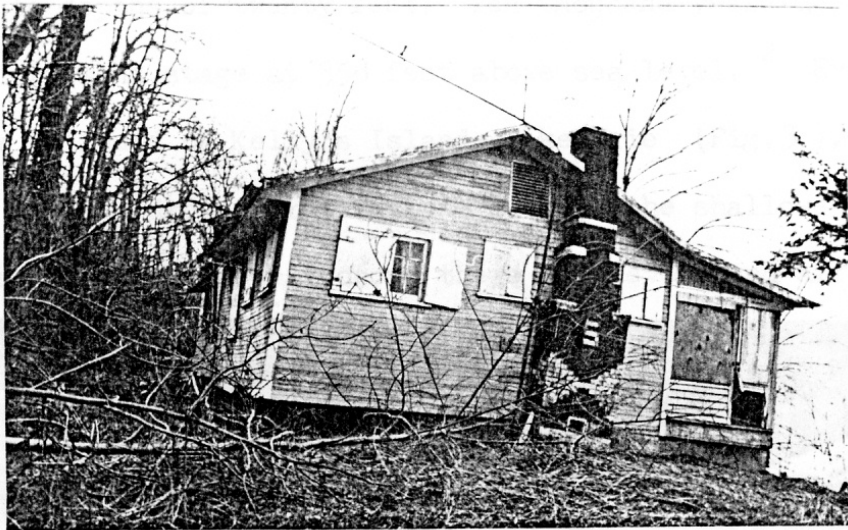
Figure 2A. Abandoned house that is located ten houses east of Laituri's residence. B. Closeup of tension fractures in chimney.

Obviously, the owner of the home below could not invest in time. This house has a dip of approximately 8° and is now uninhabitable. Tension cracks can be seen in the chimney and there is no foundation on the left side. This is a potential danger spot for young children.

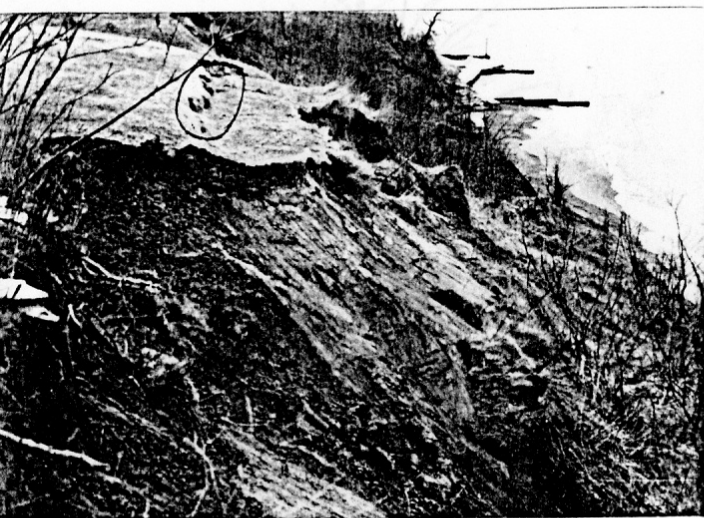
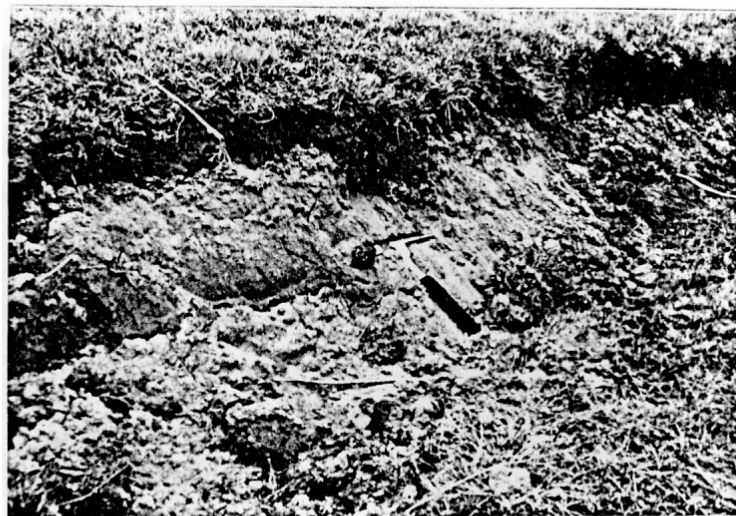
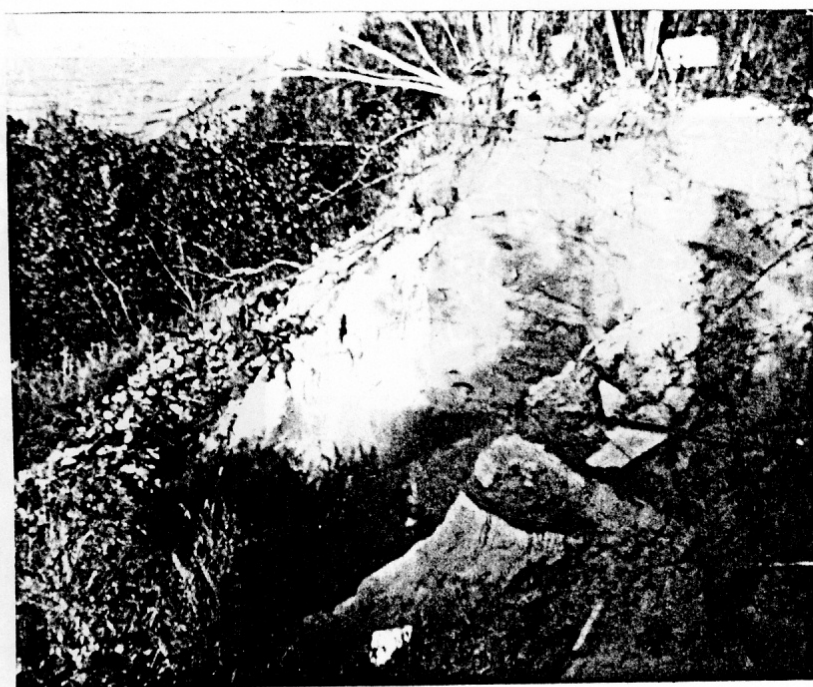
Figure 13. Slump movement observed on Laituri's residence, 1282 Lake Road, Conneaut, Ohio. (A) Newly formed slump division due to snow thaw and added precipitation. Only small tensional fractures could be seen on December 25, 1982. (B) Closeup of plane of movement. This photograph was taken in March 1983. There was a movement of 2.4 feet in three months. (C) A slump cave-in due to a substantial spring below. This photograph was taken in August 1982. It is located left of A.

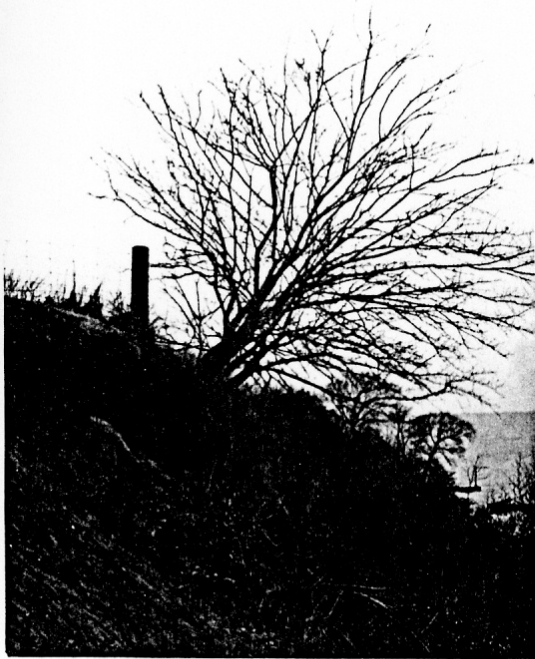
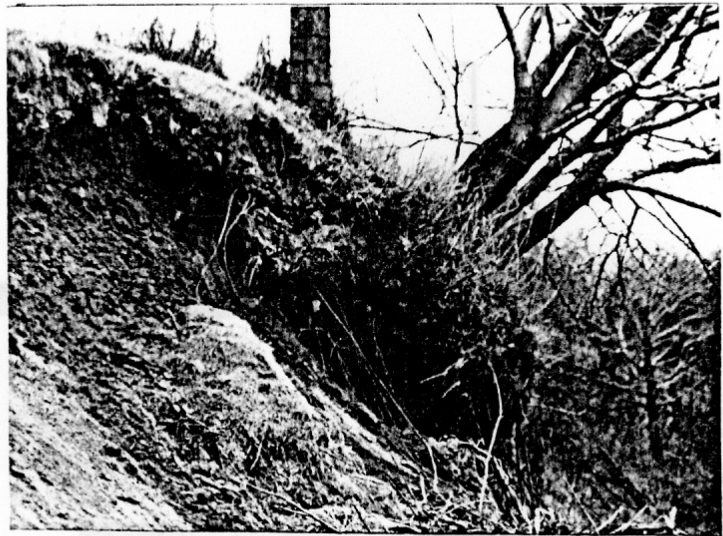
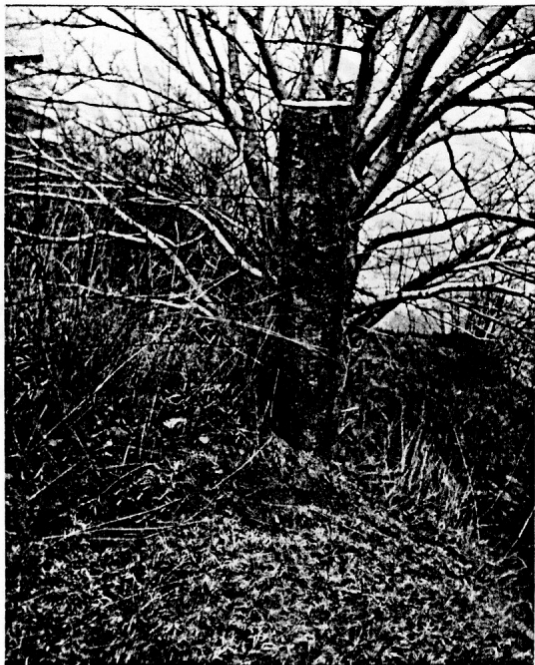
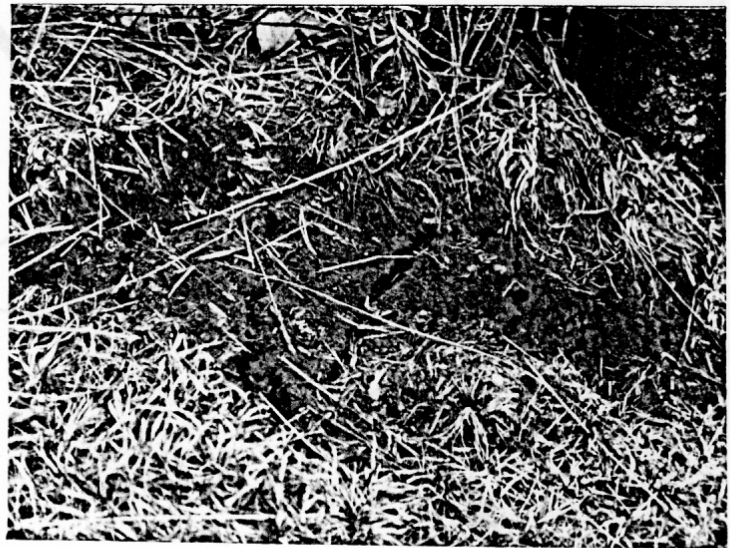
Figure 14. The tree in these photos is one residence west of Laituri's property. Measurements for slump rate were taken from the fence post to the far base of the tree along the top surface. (A) In April 1982, one could walk around the fence post safely. This photo (April 1983) shows slump of approximately three feet (See figure 15). Spring thaw and the weight of the tree enhanced rapid slump in the spring. (B) Close-up of the tree base and loss of soil. (C) Rear view of the tree, looking over the bluff. (D) Tensional cracks formed at the base of the post.

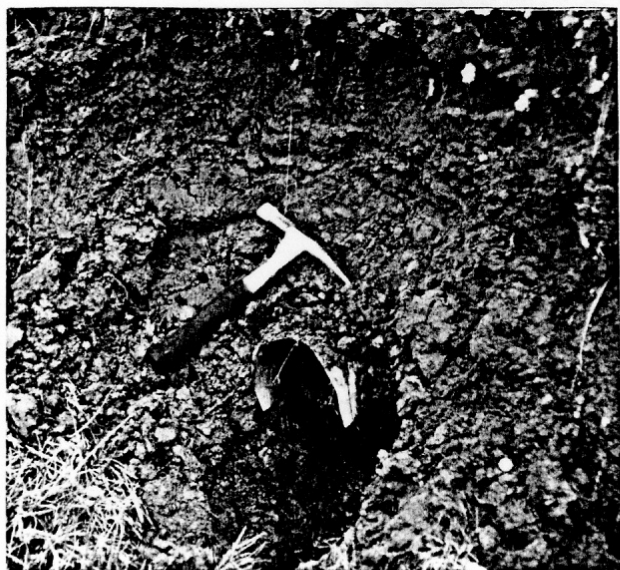
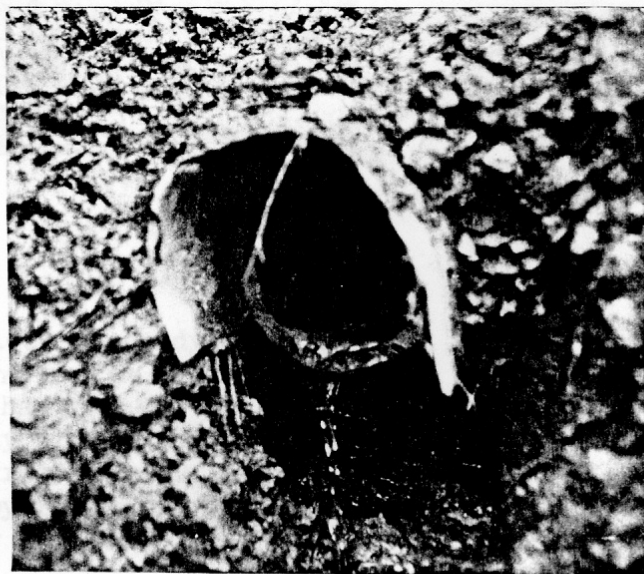
Figure 16. Drainage tubes located twenty feet below top of bluff adding water and weight to the bluff face. April 1982.

Drainage on this property is not well controlled. Septic tank overflow seeps down to the clay layer and runs out to the bluff on this plane, thus lubricating slump blocks. I also observed drainage tubes halfway down the hill (figure 16). The leakage from these tubes adds to the effect of surface runoff and sheeting that erodes the top three to four inches of soil. Gullies and rills penetrate the bluff and move several feet of material into localized areas.¹⁸ Ground-water from precipitation affects the detrius in three ways:

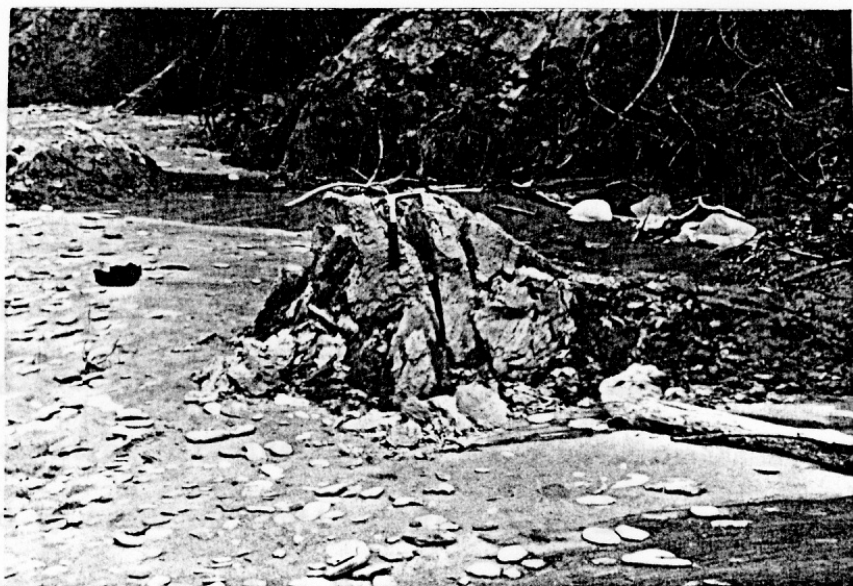
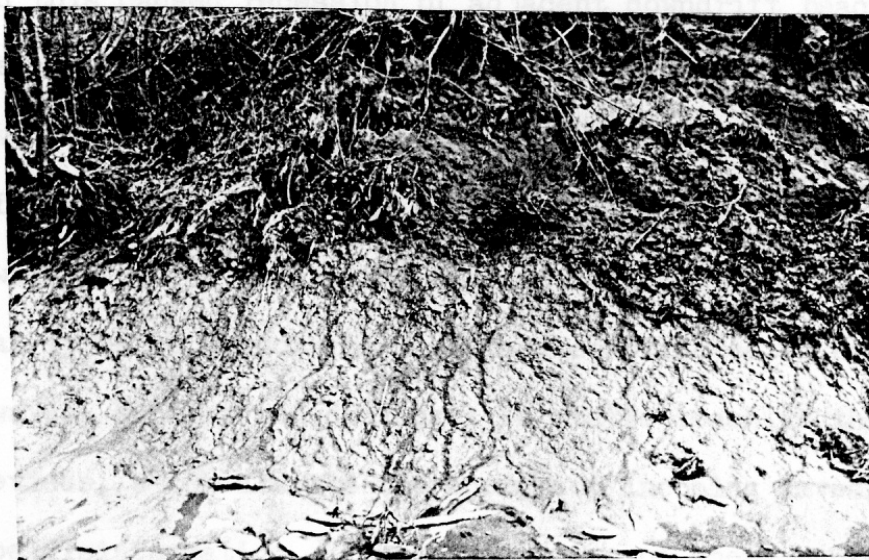
Figure 17(A) This is a slump block of sandy material that has slid over the clay layer at the bottom of the bluff on Laituri's beach. Wave action has reduced its size and broken it apart. (B) The stratigraphy of the bluff is shown with two distinct layers. Course-grained sandy lacustrine deposits on top are penetrated easily by rainwater. This water seeps out on top of the glacial clay layer.

Stratigraphy = The layers of soil in this area are an important factor in determining the slump seen. At the toe, a clay-sized glacial till with angular pebbles and poor sorting is approximately two meters thick. This bluish clay of approximately Cary age is overlain by a layer of old sandy lake deposits with rounded and polished grains deposited from a glacial lake of higher level. This top weathered bed slides easily over the saturated clay layer to the lake. See figure 17 B.

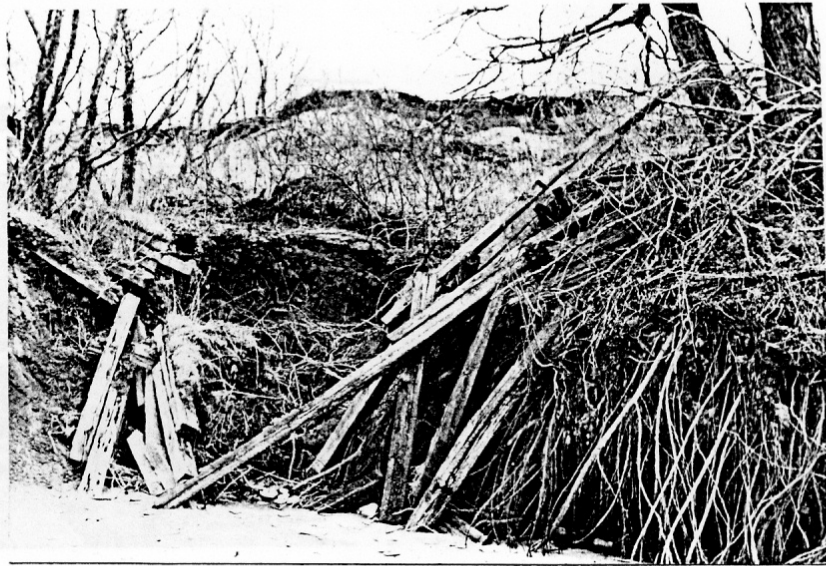
Figure 23. This retaining wall was built just west of Laituri's house in the early 1960's. Slump blocks on the high bluff and the weight of the tree in the right corner pushed through this wooden wall.

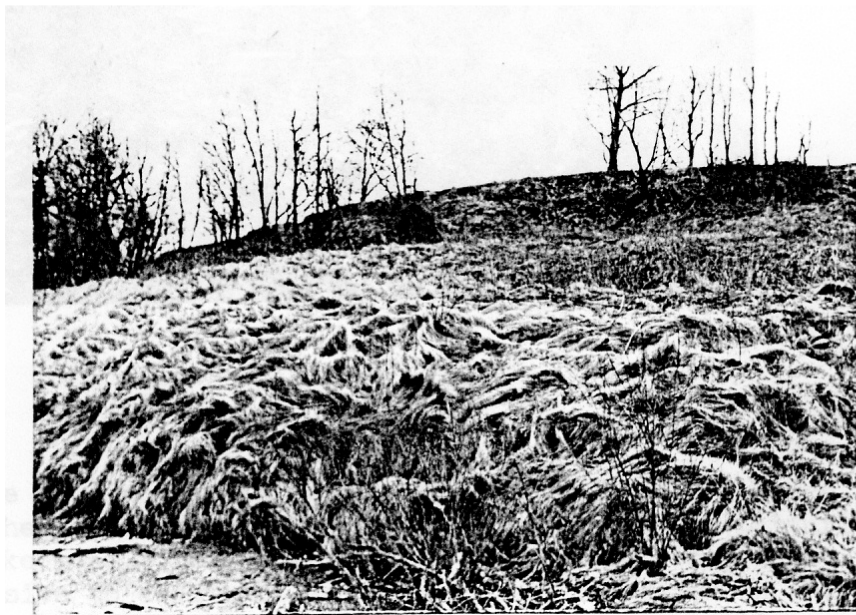
Figure 24. Just west of Laituri's the bluff was leveled with bulldozers. Added vegetation and clearing of trees has stabilized this gentle slope. There is no slump, just some imperceptible creep.

Consultation and construction with a reputable firm is highly recommended for stabile and accurate protection. Remember that these devices must withstand the test of time and storms. Figure 23 shows a retaining wall that failed in about 20 years. Other actions will also help one's erosion problem. Decreasing the slope angle to a ratio of 1:15 inhibits downslope movement by gravity. Just west of Laituri's, the bluff was leveled and excess vegetation was planted. It seems to be effective. See figure 24.

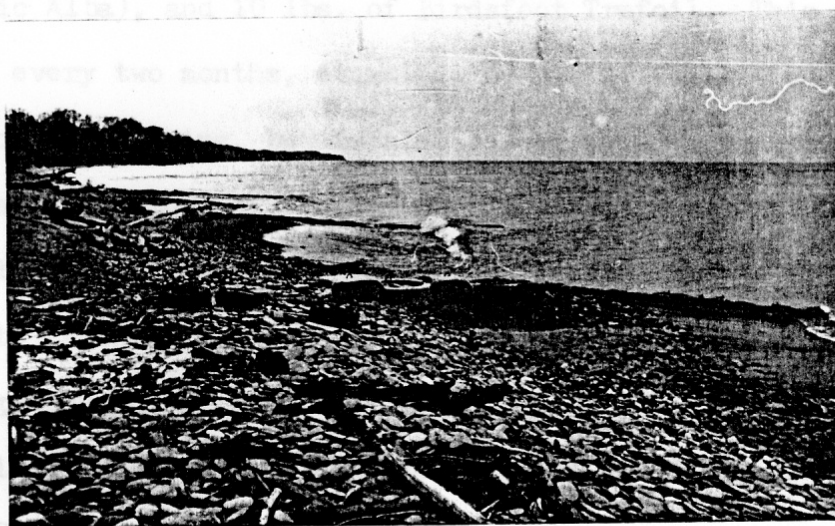
Figure 25. Two sets of groins that both develop a beach. (A) These sturdy groins are three houses west of Laituri's on Lake road. They are nineteen years old. They were expensive to construct and have caused recession on the adjacent shore property, but have stopped wave action considerably. (B) A less expensive groin field is constructed at Harrington Point, .1 mile east of Laituri's. Cement was pored into smaller blocks and also steel drums further up the shore, but tires were useless. The beach of about fifty yards was created over a longer period of time than A. Equilibrium seems to have been reached.
